RE: Site Inspection, Energy Fuels Nuclear, McCormick Tunnel and MiVida Mine, M/037/028 San Juan County, Utah

Date of Inspection: June 24, 1999
Time of Inspection: 0820 - 0945 and 1010 - 1159
Conditions: Clear skies, getting warmer
Participants: Tony Gallegos and Doug Jensen, DOGM

Purpose of Inspection: To examine the status of these reclaimed sites while in the area

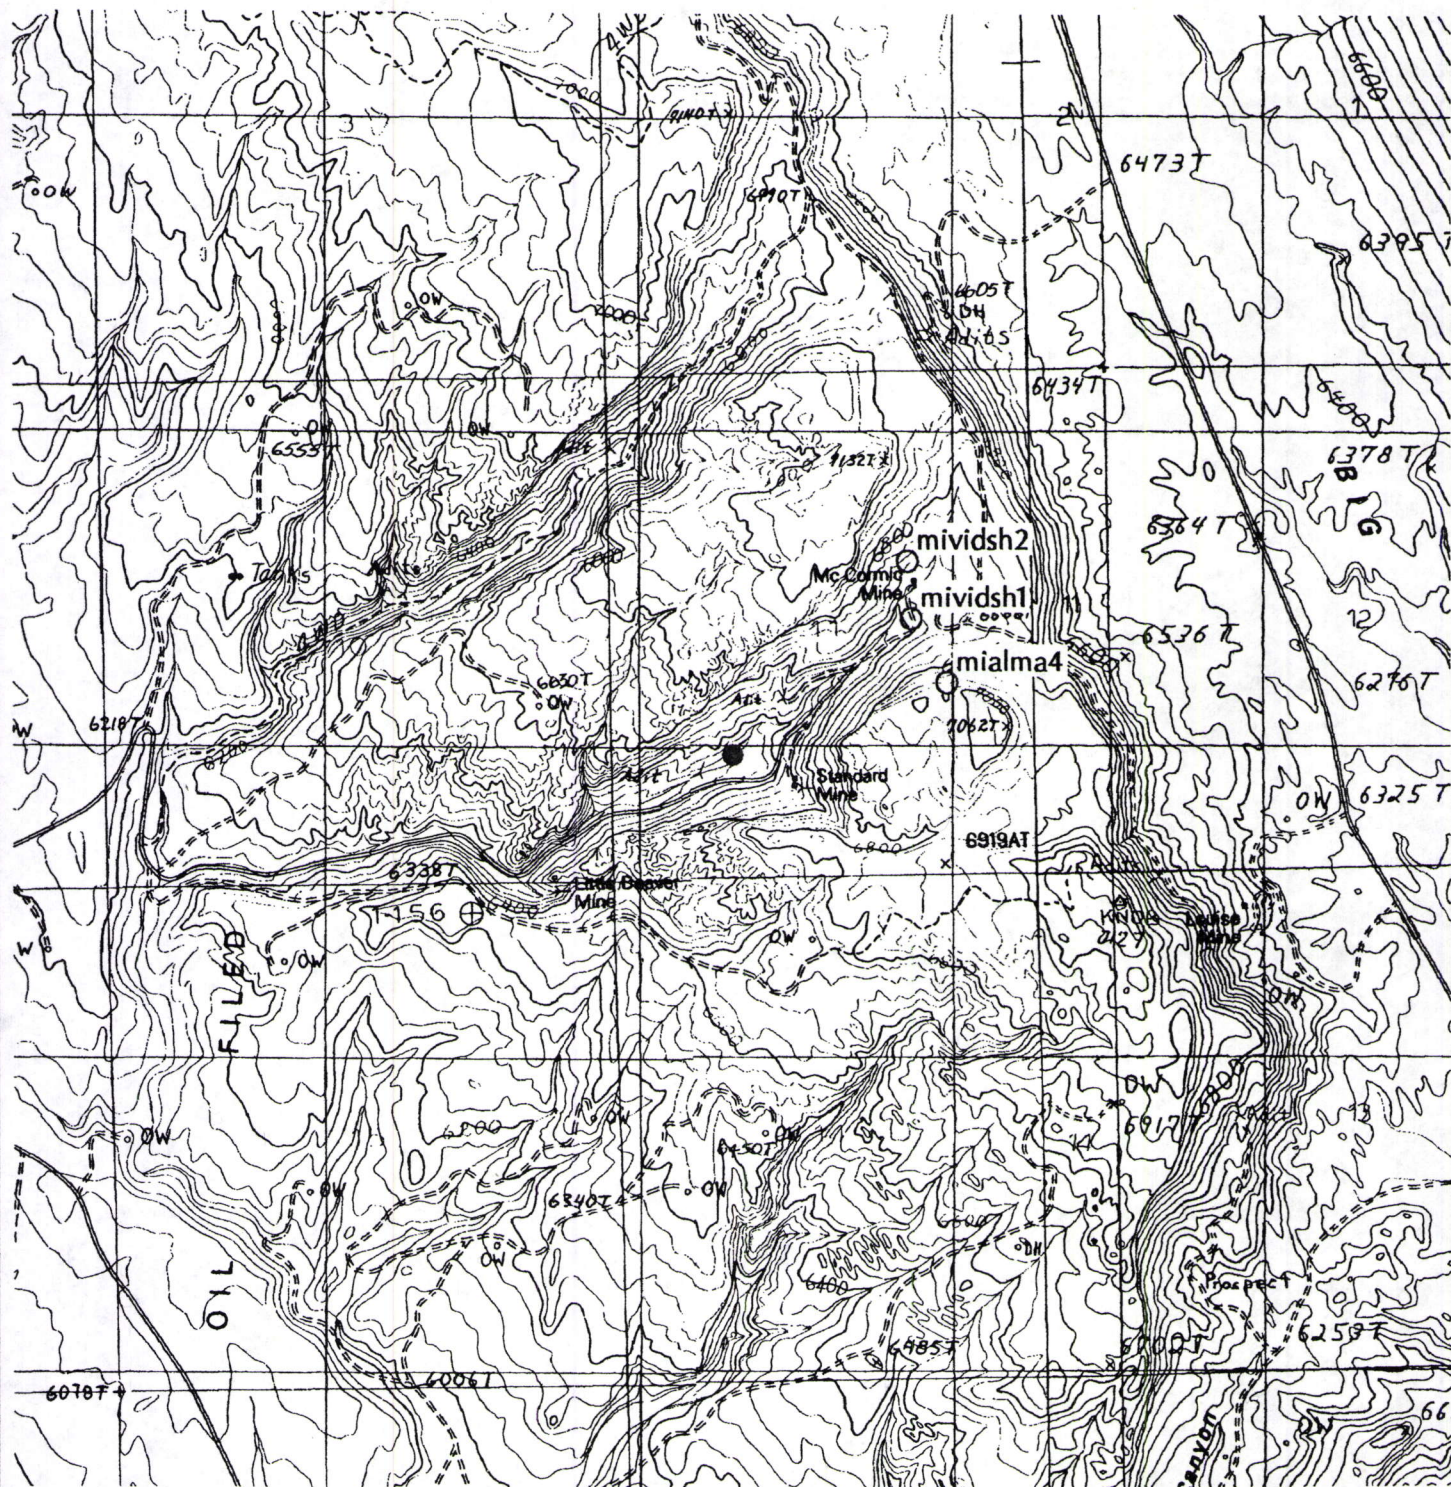
MI VIDA - FORFEITED - M370028

Quad: Sandstone Draw - UTM: 652301, 422796

mialma4-Lm3 652983 E, 4228206 N

mividsh1 652869 E, 4228411 N

mividsh2 652857 E, 4228594 N

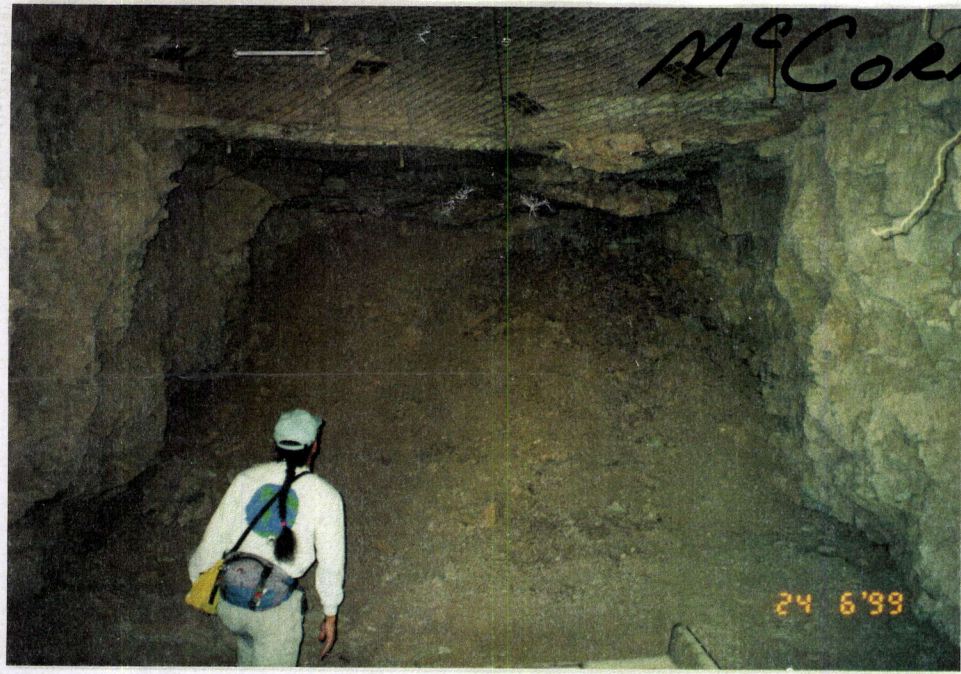
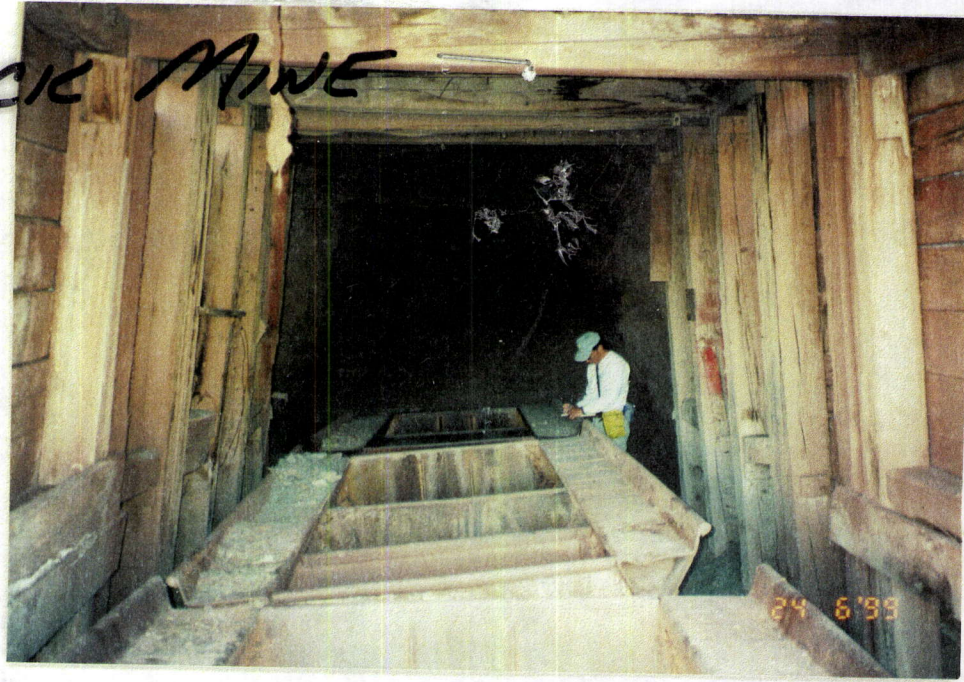
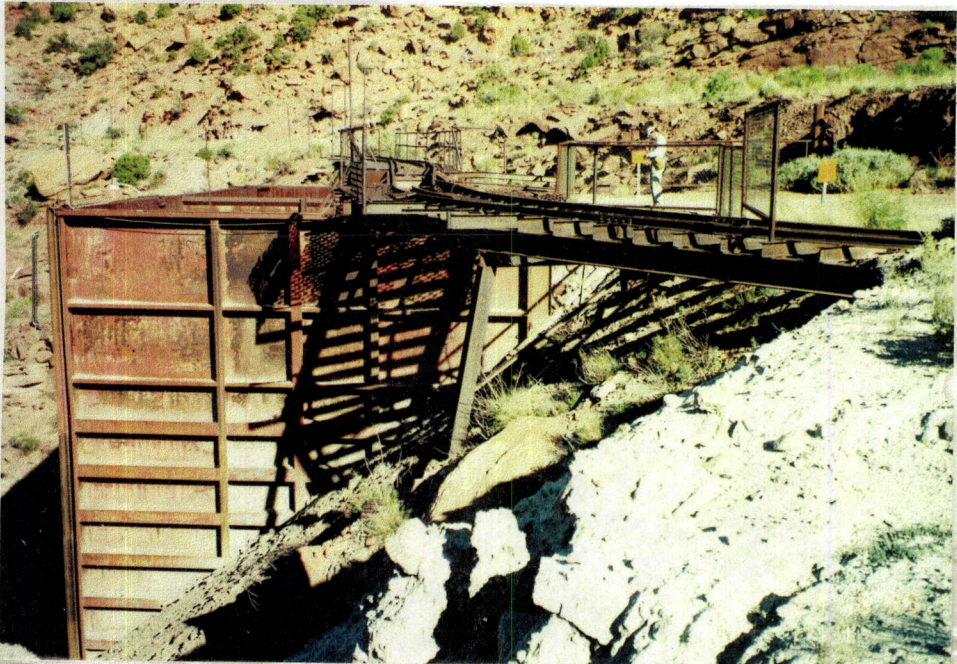
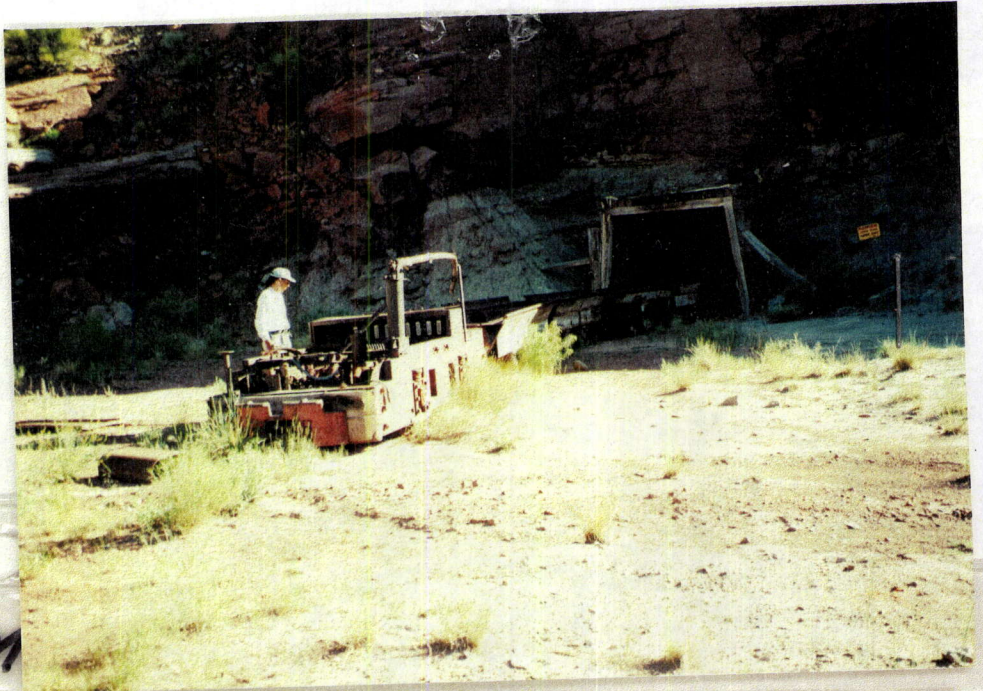
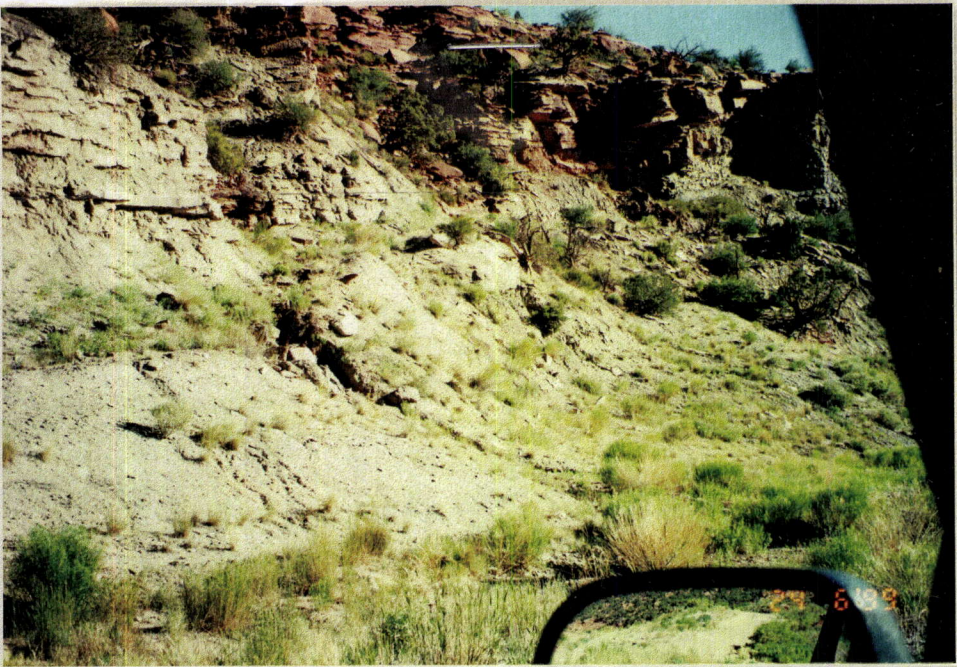
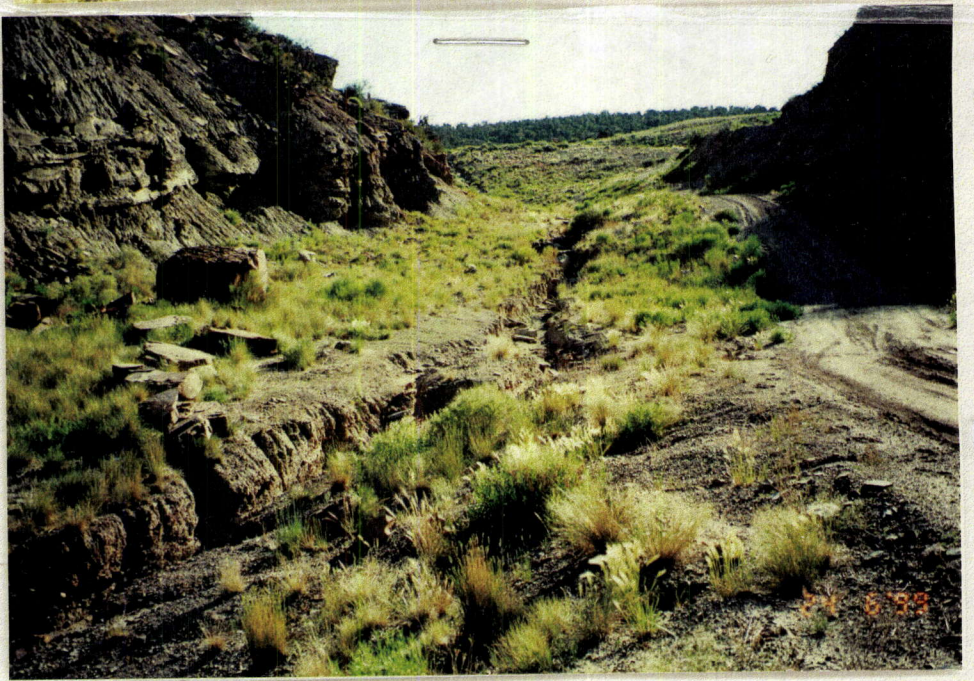
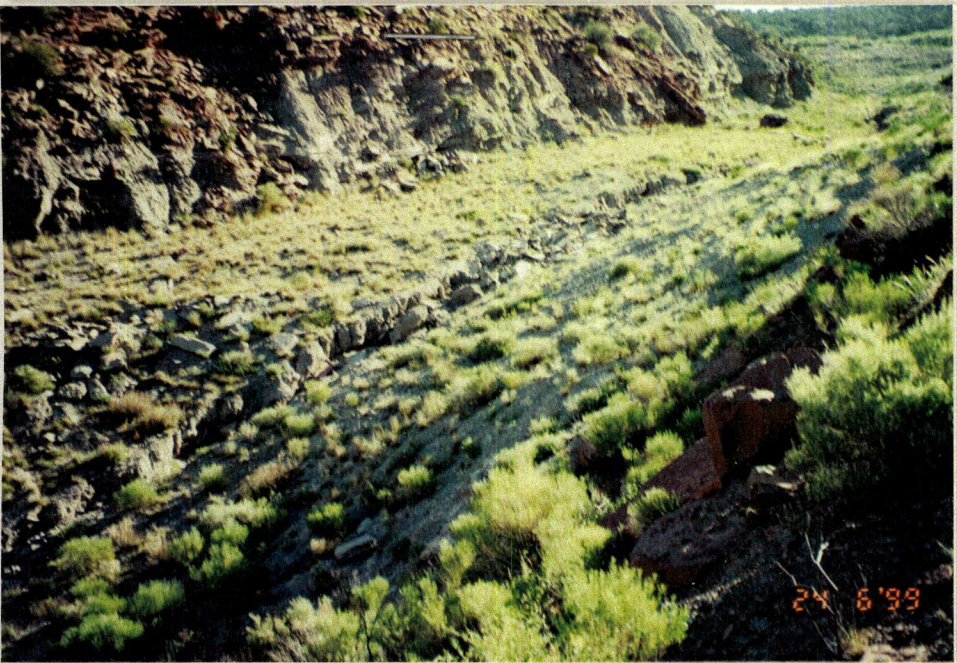
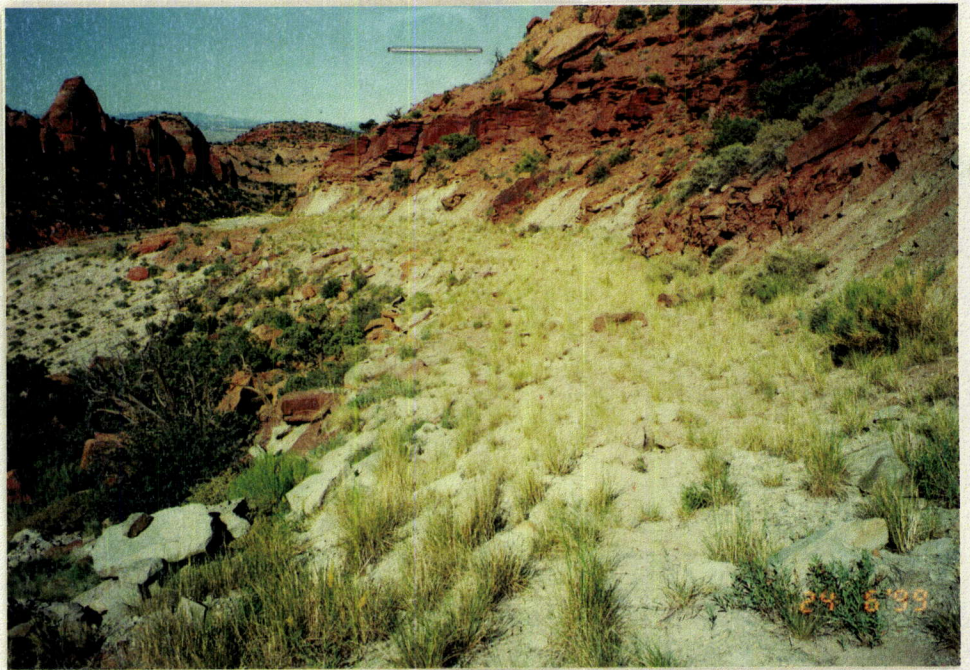
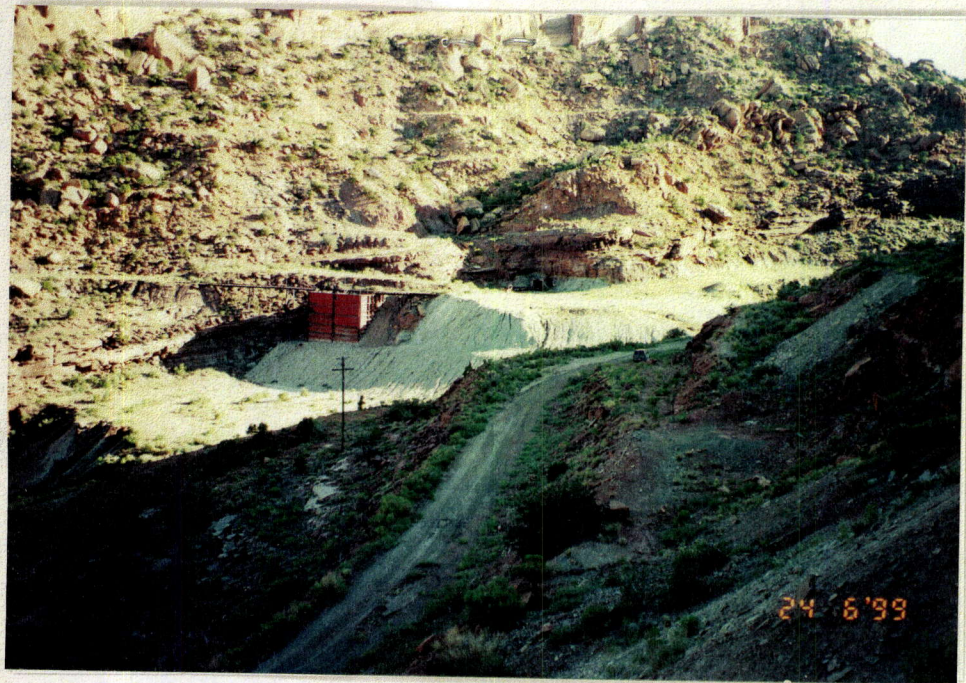
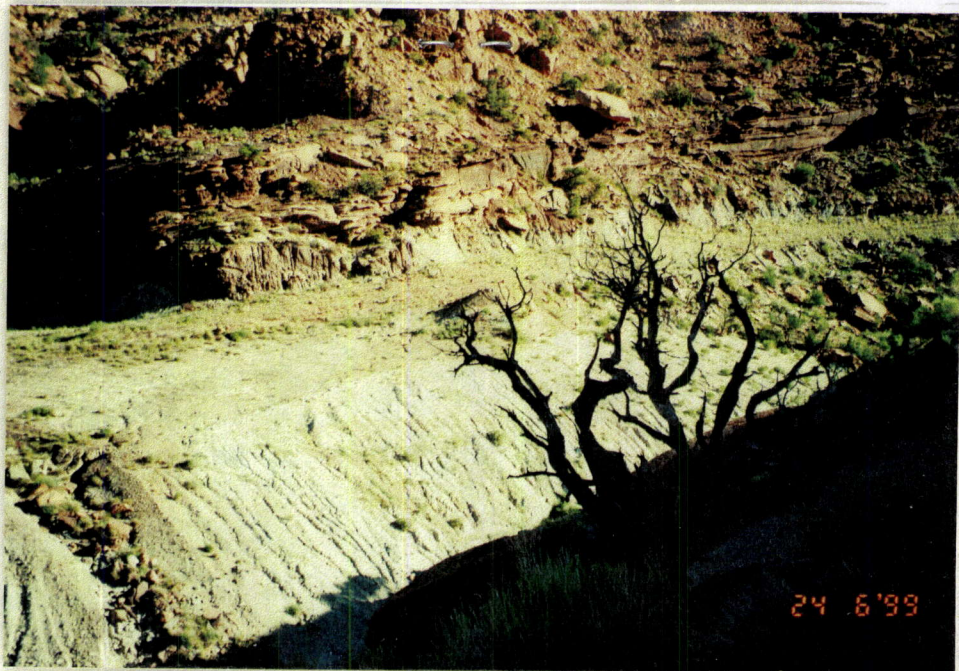
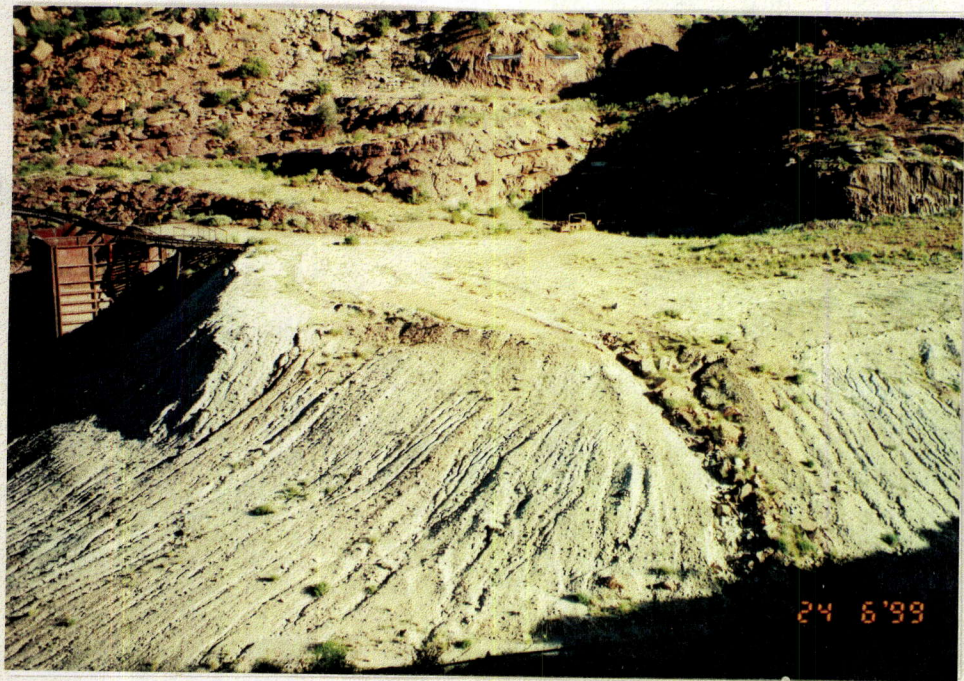
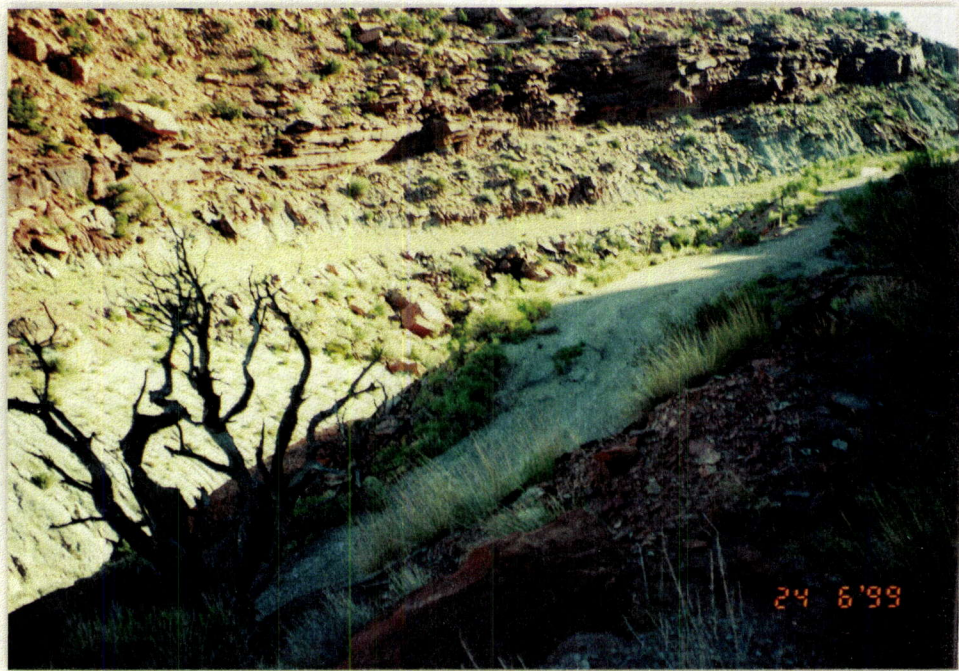
McCOMBIC MINE

In conclusion, the pad at the McCormick Tunnel will need some drainage restoration in the near future to prevent erosion of the dump face. The GPS information will be useful in locating the original discovery shaft and claim corners for placement of historic markers. Photographs were taken of the various features
